REHABILITATION AND SEISMIC RETROFIT OF RESIDENCIAS GALILEO

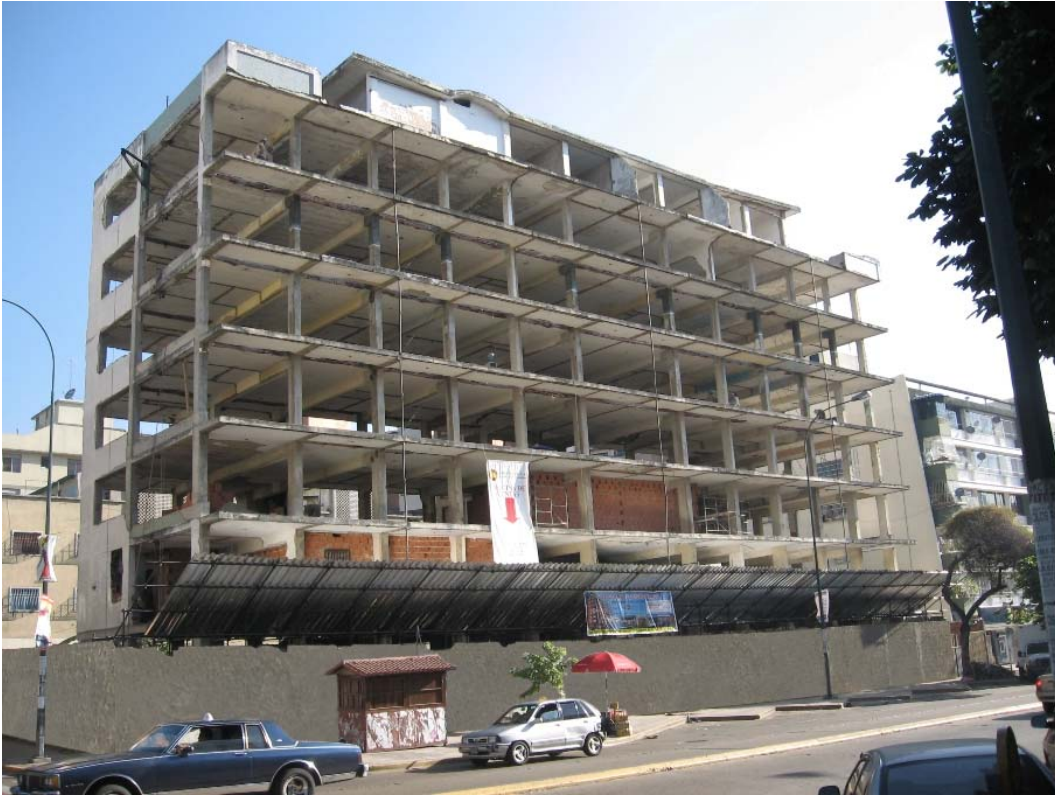
Fig. 1: Building before retrofitting
Concrete frames in transverse direction and absence of beams in longitudinal direction

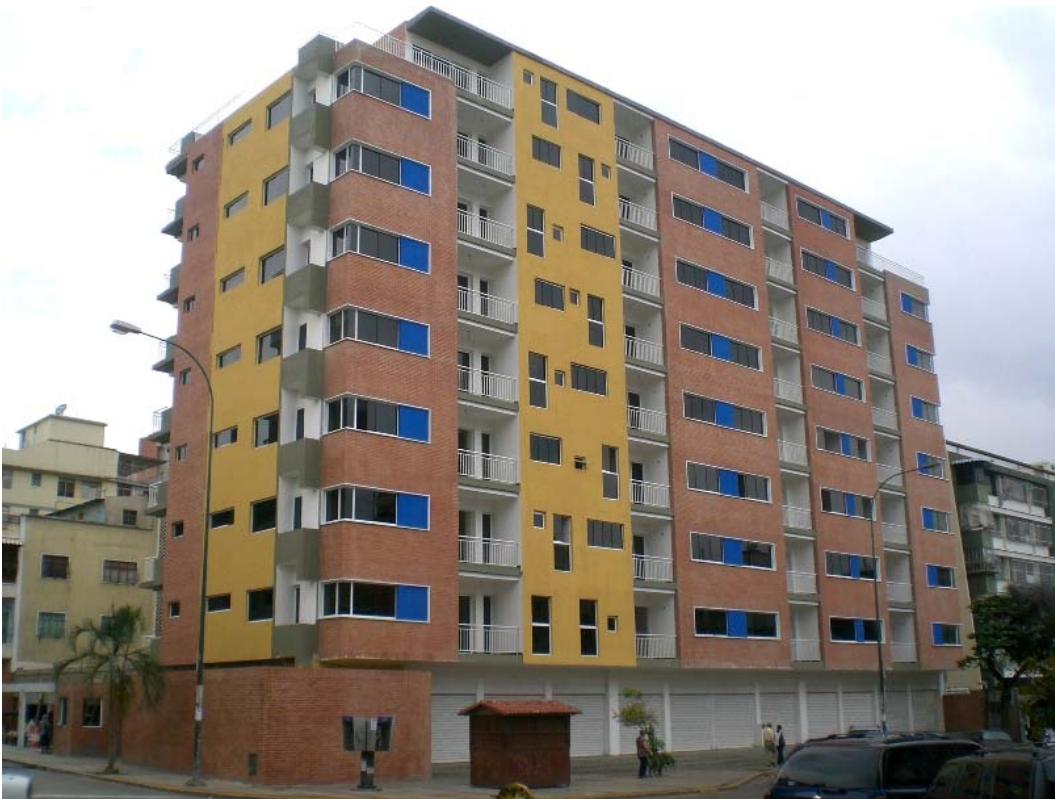
Fig 2: Building appearance after refurbishment
